Bank of New South Wales (former)

Location: 39/41 Victoria Avenue, Whanganui
Heritage NZ Pouhere Taonga List Number: 968

Built Heritage Inventory

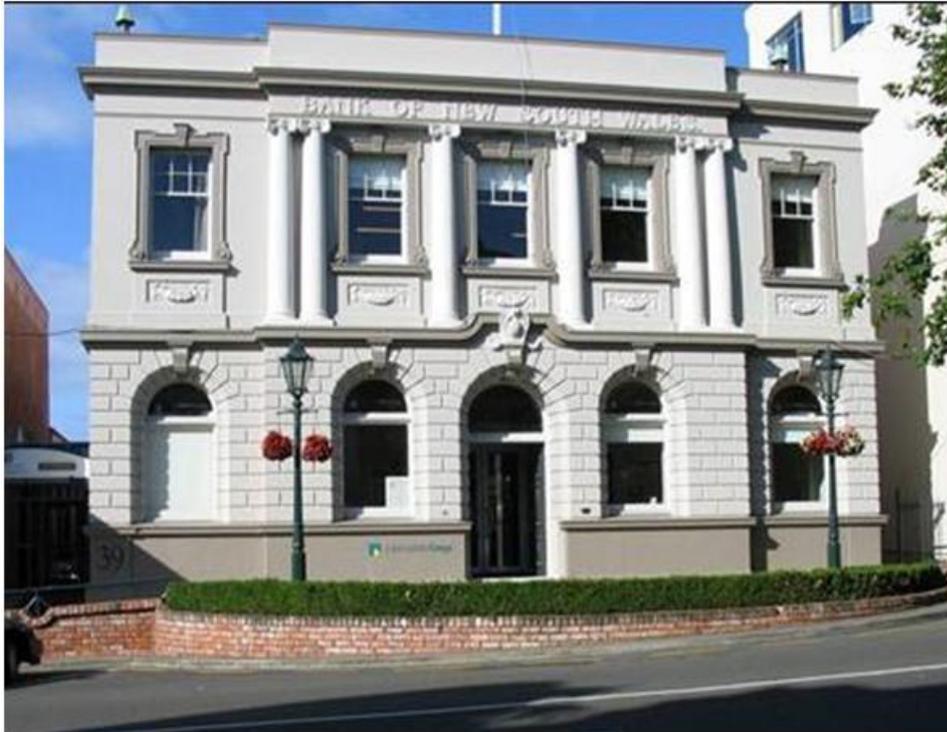
Physical Description: The two storied, rendered, rectangular planned building, has a symmetrical street elevation with rusticated ground floor and classically designed plastered upper first floor. Ground floor windows are round headed while the first floor are rectangular but with wide architraves, wide shoulders, scrolled bases and keystones. Under each of the first floor windows is a panelled base with a swag. The centre of the street elevation has a shallow projecting pavilion with the central entry flanked by windows either side on the ground floor and with a colonnade of single and double Ionic columns on the first floor. Between the columns are three windows matching the openings below. The building has a plain parapet with ornate cornice forming the entablature of the building and a smaller cornice at the junction of the ground and first floors rising slightly in the centre to meet a cartouche keystone. The name "Bank of New South Wales" is embossed on the parapet.

Although the upper pediment, parapets and chimneys were removed in 1934, the rest of the Avenue façade is totally original. The name "Bank of New South

Wales” remains on the parapet. The iron railings on either side were removed in 1992, although the gates are still in place on one side. While the windows all appear to be original the entrance has been altered (probably in the 1970s modernisation) with a new inner doorway and replacement glass above the outer front door.

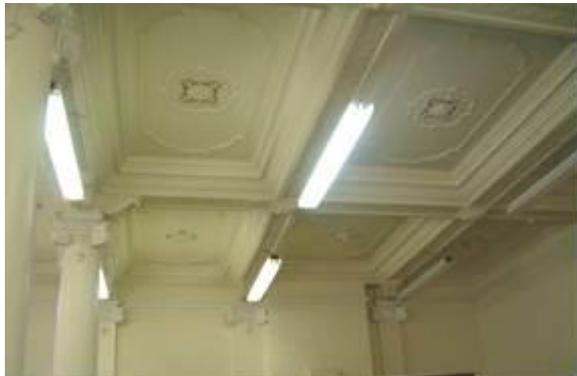
The original Wunderlich ceilings are still in situ premises photograph taken in 2003 before renovations)

Internally, the banking chamber retains its pressed steel ceiling and columns with plaster decorations. The 1970s partitions and staircase work had detracted from the general style of the banking chamber and its adjacent offices, but these were largely removed in the 2006/07 alterations. At the same time, a new side entrance giving access to the first floor was created with the alteration of the 1970s staircase position.

compressed steel and is really most effective.” The ceiling was divided into 18 squares of “elaborate design and dainty colouring” all supported by two pillars of reinforced concrete decorated with plaster ornamentation.

The building retains all its original external features, apart from the upper pediment and parapet, as well as its internal ceilings and columns. The Wunderlich pressed steel ceilings, in particular, are delightful features, reflecting the fashion for these decorative items at the time.

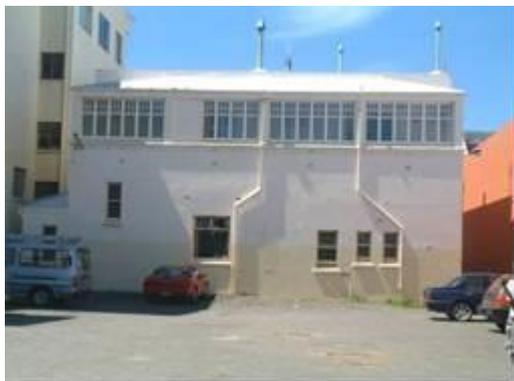
The 1927 rear addition for the manager's (photograph taken in 2003 before renovations)

- 1927: A major addition at the rear, providing extra accommodation for the bank manager and family (including a maid's room). Architect: Leopold Atkinson; builder DW Gilbertson. The building permit issued in Sept estimated the cost to be £2,182. This addition included a closed-in balcony at the rear and a new, separate entrance and stairway to the right of the building. (Note that previously the bank had two stories extending to one-storey one at the rear.)

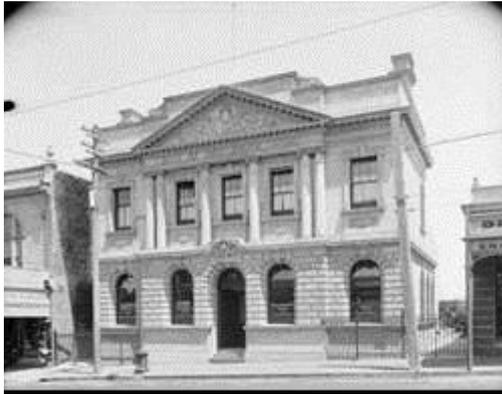
The bank as it appeared when built in 1910. Note trees in garden at rear. Frank Denton photograph, Alexander Turnbull Library No. 1/1 017399 G.

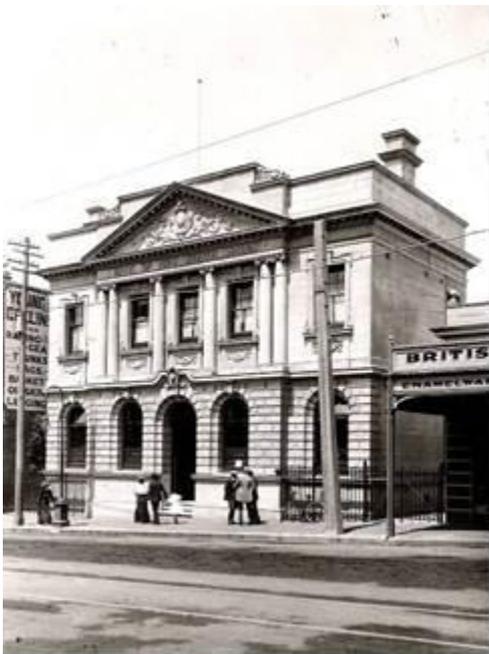
Photograph showing chimneys. ATL G16631 1-1

- 1934: The upper pediment, parapets and chimneys were removed, as they were deemed to be an earthquake hazard following the Napier earthquake.
- 1936: Concrete garage erected at the rear, reflecting the need to provide accommodation for the manager's car at this time.
